SUBJECT: PRODUCT ALERT for Whirlpool 90% dedicated horizontal gas furnaces.

MODELS: All WFCH series units.

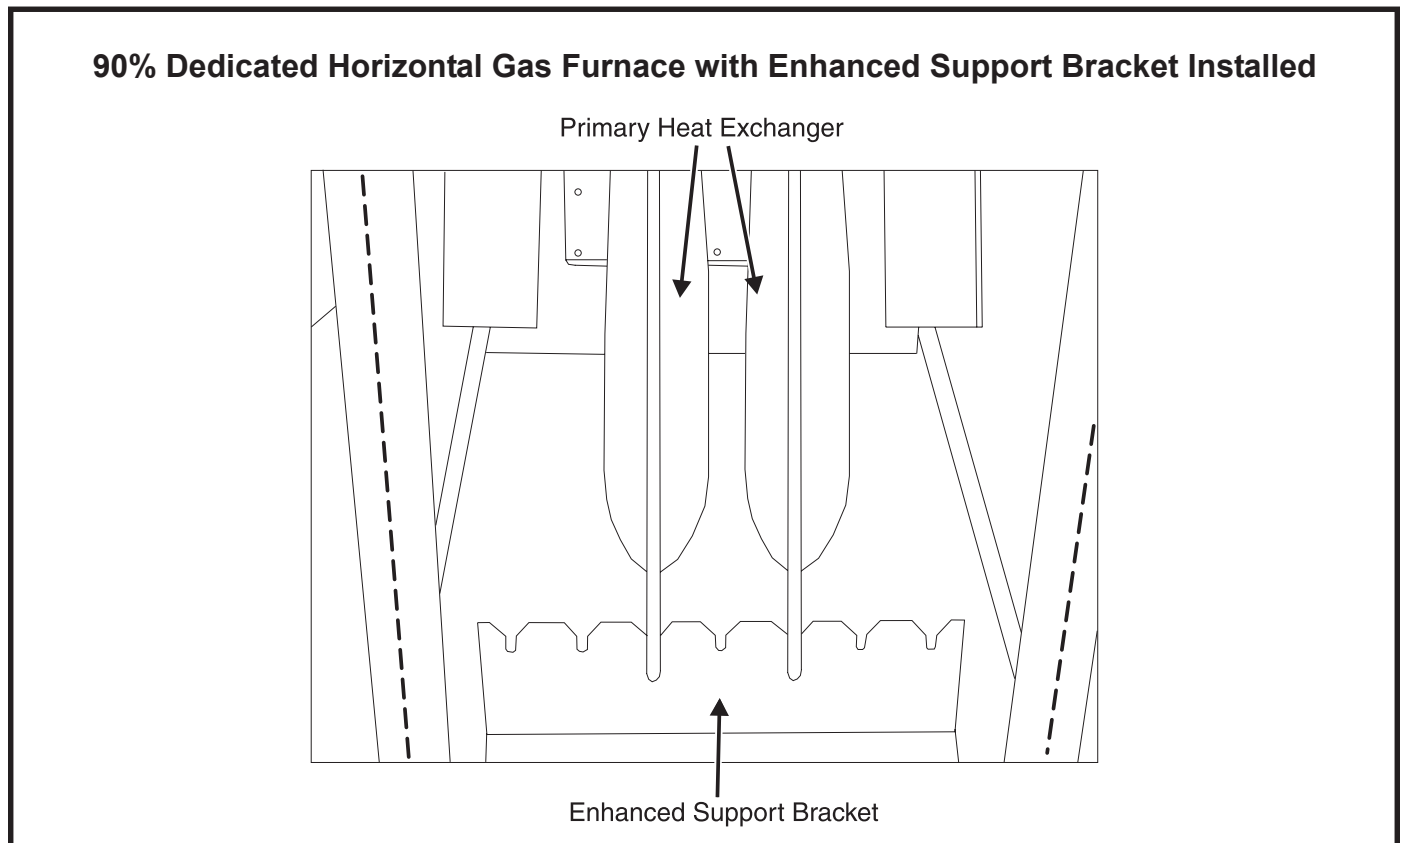
Figure 1

FACTORY CORRECTIVE ACTION: All product produced by Armstrong after November 1, 2003 (beginning with serial number 8403L) will contain an enhanced support bracket. Any product produced before November 1 (serial number 8403K and prior) that has been corrected can be identified by the "Bracket Installed" label on the carton.

All WFCH units which have not been installed and do not have the "Bracket Installed" label on the carton must be returned to you participating distributor. From this point on, do not install any WFCH units that do not have the enhanced support bracket installed as shown in Figure 1.

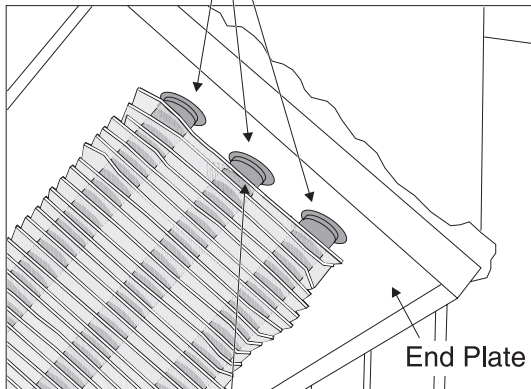
Secondary heat exchanger tubes properly attached to plate

Top fin of secondary heat exchanger should be no more than 1/4" from endplate.

5. If the heat exchanger/transition box end plate connection is intact, re-install the main limit control removed in Step 2.
6. Ensure that the unit is properly vented and that the combustion air intake pipe meets the minimum length requirement of 5 feet (see Figure 5).

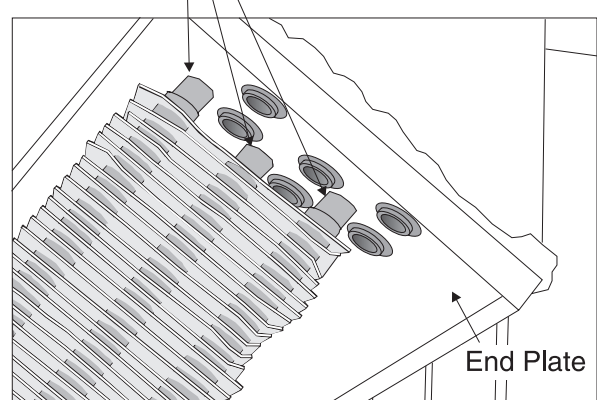
DISCUSSION: In the event the specified units are exposed to rough handling, separation of the secondary coil from the primary heat exchanger may occur. If separation has occurred and the PVC pipe is not yet installed in the combustion air connection (intake), flame may exit the connection opening for a brief period of time before the safety circuits shut down the flow of gas within the unit.

Secondary heat exchanger tubes separated from plate

4. See Figure 4 to aid in determining the integrity of the secondary heat exchanger and the outlet end plate connection. If separation has occurred, the unit must remain shut down. Remove the unit from service and replace with a new unit. Contact your participating distributor to obtain a new unit and appropriate warranty paperwork.
