SUBJECT: PRODUCT ALERT for Whirlpool 90% dedicated horizontal gas furnaces.

MODELS: All WFCH series units.

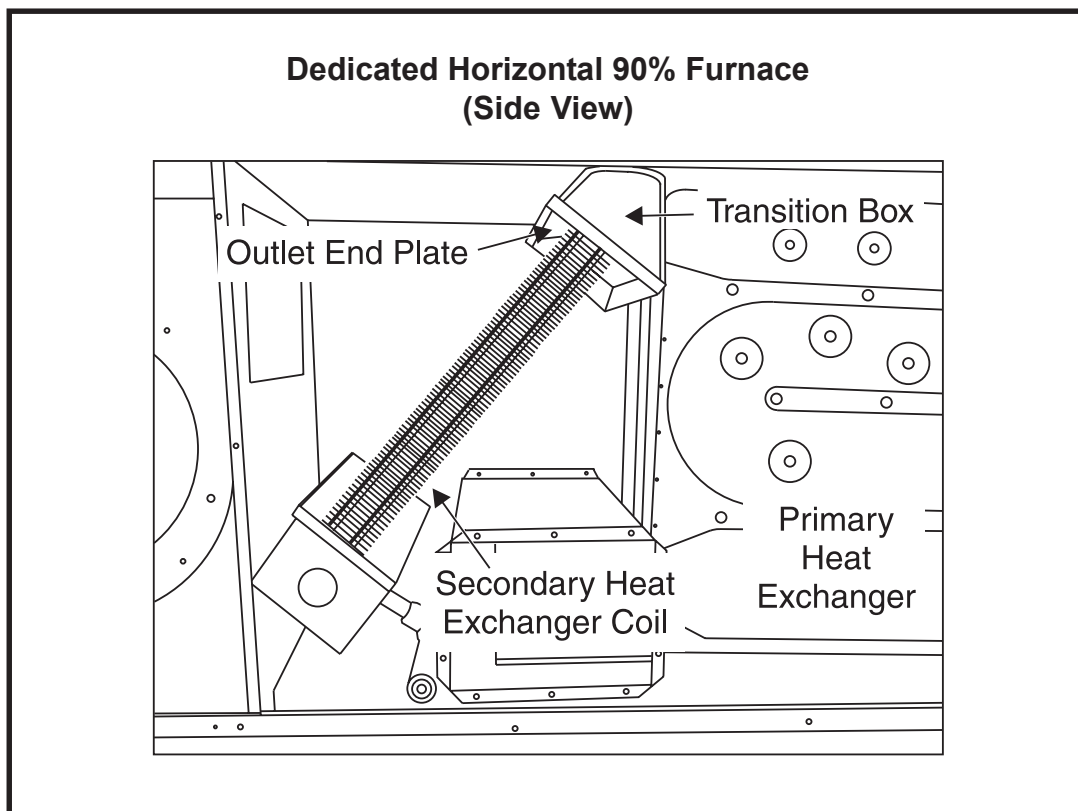
4. See Figure 4 to aid in determining the integrity of the secondary heat exchanger and the outlet end plate connection. If separation has occurred, the unit must remain shut down. Remove the unit from service and replace with a new unit. Contact your participating distributor to obtain a new unit and appropriate warranty paperwork.

Secondary Heat Exchanger Coil/Transition Box End Plate Connection

Secondary heat exchanger tubes properly attached to plate

Top fin of secondary heat exchanger should be no more than 1/4" from endplate.

Secondary heat exchanger tubes separated from plate

5. If the heat exchanger/transition box end plate connection is intact, re-install the main limit control removed in Step 2.
6. Ensure that the unit is properly vented and that the combustion air intake pipe meets the minimum length requirement of 5 feet (see Figure 5).
